# **Former Plainwell Impoundment Time-Critical Removal Action Weekly Construction Update**

**Progress Report #65—September 29, 2008**

**Work Completed: September 11-September 24, 2008**

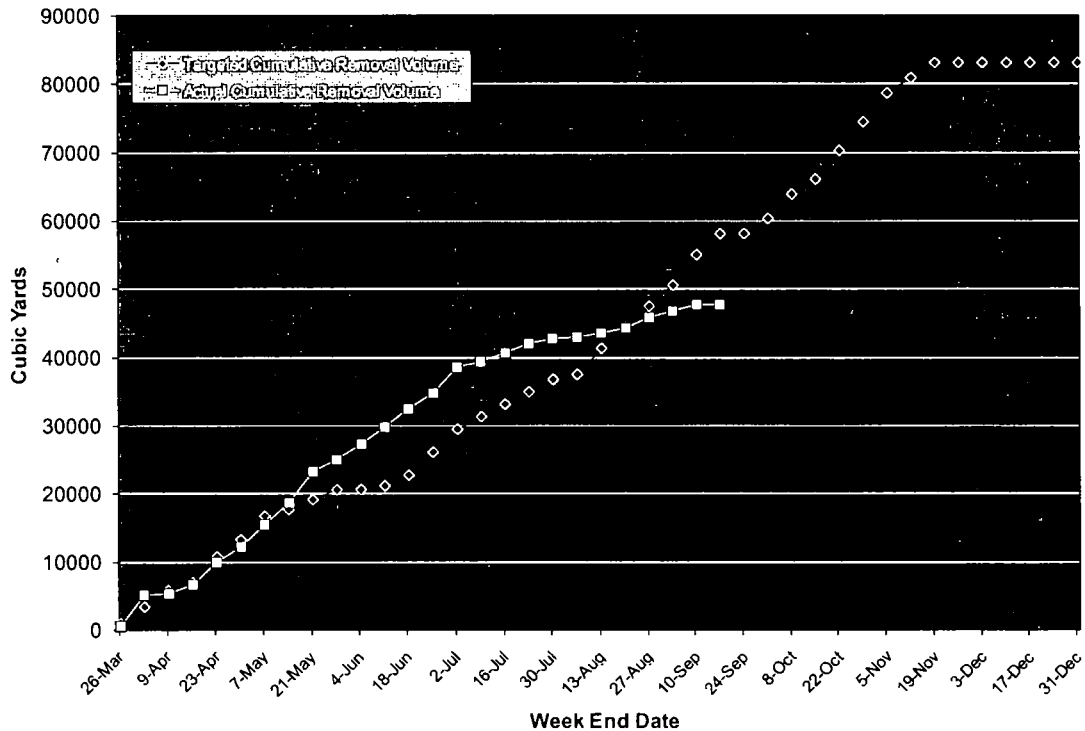
## Removal Progress

Removal Progress was suspended from September 13 through September 23, 2008 due to inclement weather.

Targeted volumes are neat and subject to change due to additional excavation done at request of USEPA.

Actual volumes removed below the targeted volumes potentially due to the conservative estimation methodology used to develop targeted figures and due to the actual topographic conditions encountered at the site, which could result in smaller volumes needing to be removed than originally estimated. The targeted volumes have been increased by 10% to account for additional material that could be removed as a result of over-excavation and additional removal in response to confirmation sampling. Soil/sediment removal activities are on schedule based on the ARCADIS BBL ES 4/30/07 Plainwell TCRA Construction Schedule.

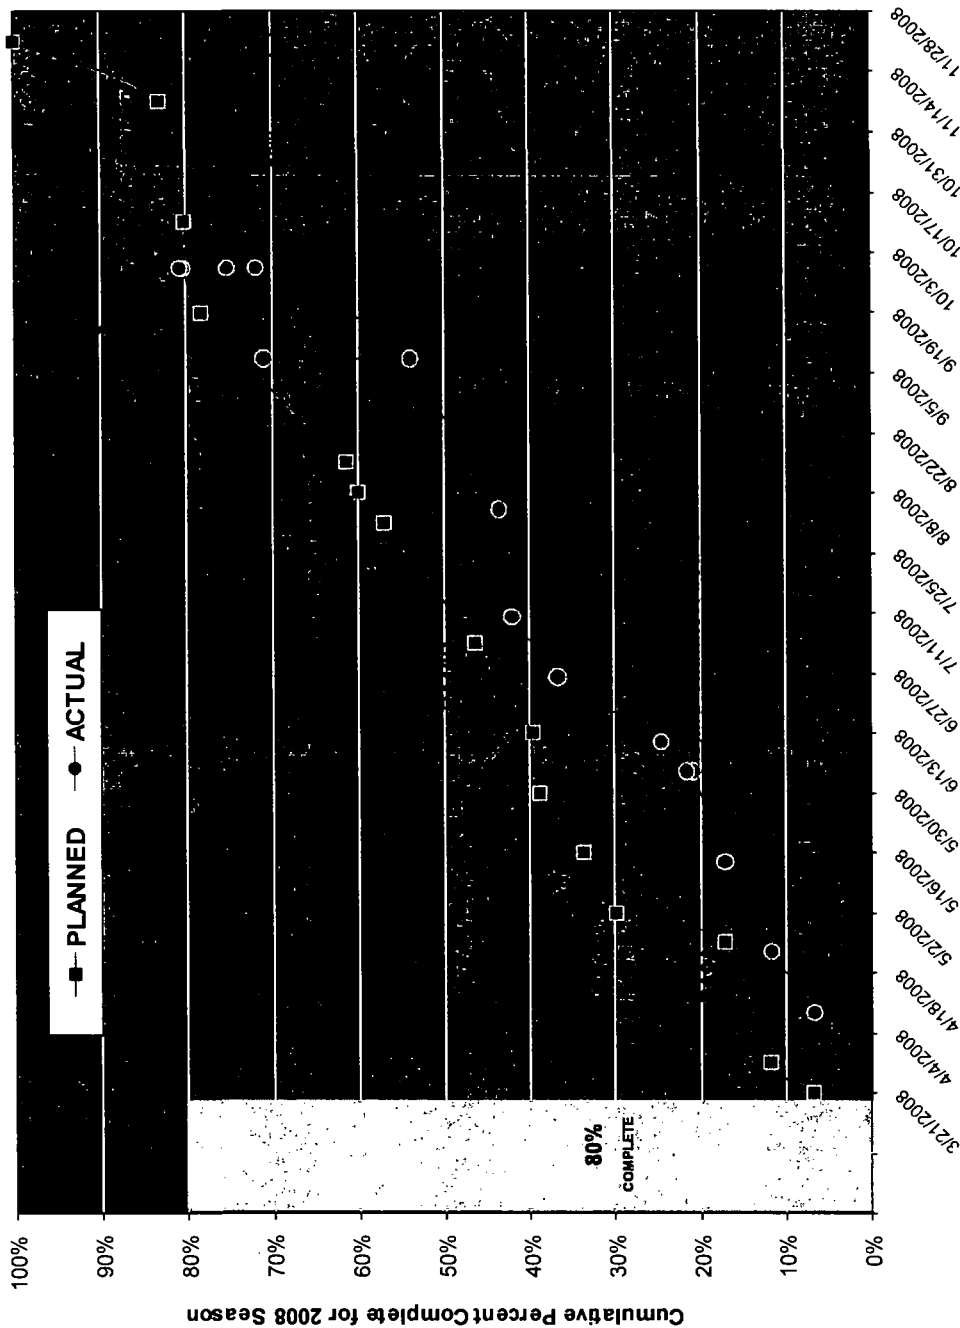
**Removal Progress**

Removal Progress was suspended from September 13 through September 23, 2008 due to inclement weather.

For Areas where removal is less than 100% complete, the data point shown is an estimate based on area and volume considerations.

'Complete' is defined as removal of all targeted materials as detailed in the Plainwell TCRA Design Report.

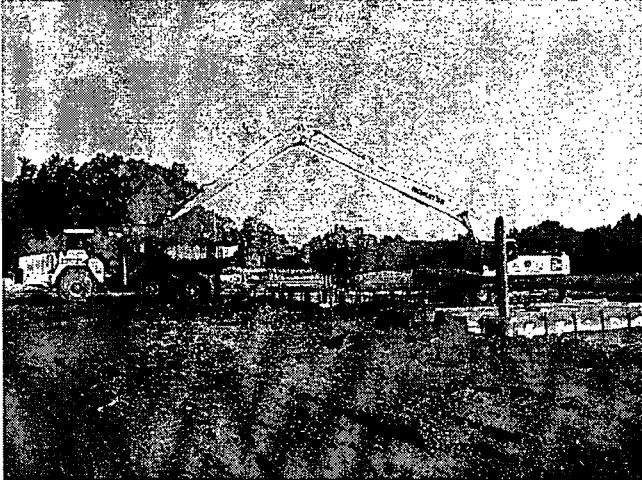
Removing soil and sediment from Mid-Channel A.

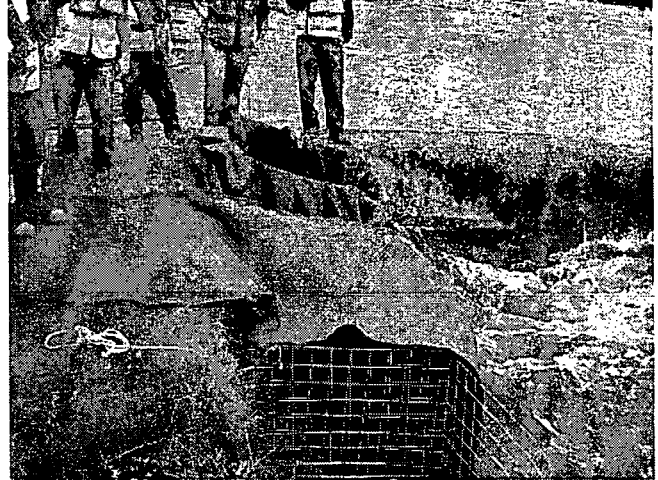
Installing an erosion control system on the bank of the earthen embankment between WCS and existing spillway.

- Constructed an erosion control system comprised of gabion baskets, geotextile, rip rap and concrete at the upstream end of the earthen embankment between the WCS and the existing spillway.

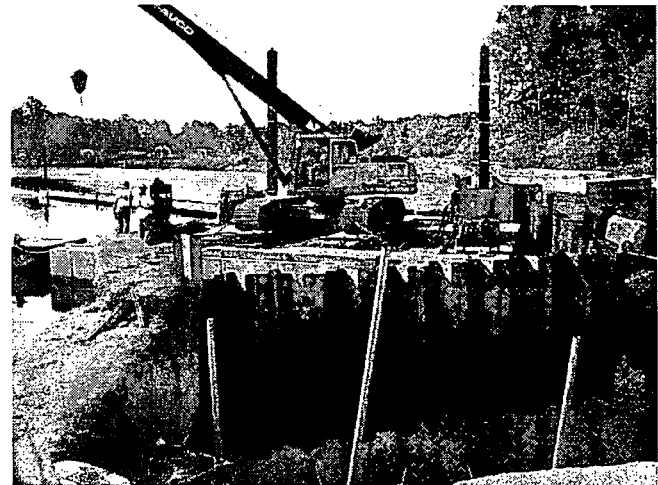
Installing temporary steel sheeting to connect the Phase 2 Cofferdam to the existing spillway.

- Installed temporary steel sheeting to connect the existing Phase 2 Cofferdam to the western concrete wing wall of the existing spillway.
- Began an initial site assessment of all removal areas, resuspension control systems, the Phase 2 Cofferdam and the WCS structure following the increased water elevations during flood stages.
